Excerpt from report: "Upper Clark Fork Diversion Inventory," by Trout Unlimited for Watershed Restoration Coalition, Deer Lodge, MT, December, 2011.

Lost Creek — Lampert-Hadley Diversion

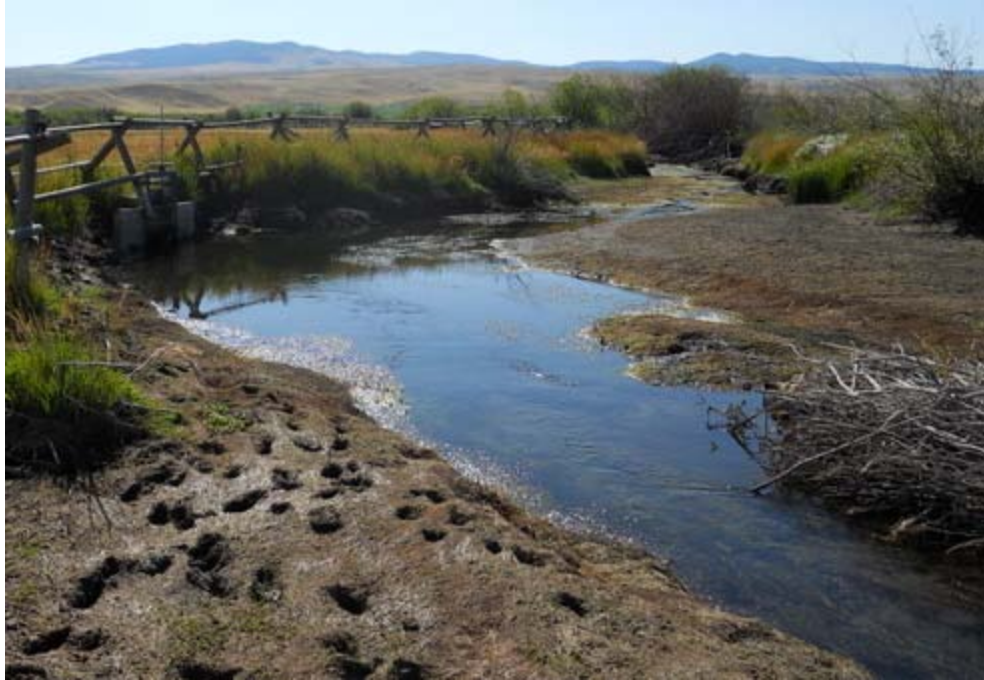
Recommendations— Lost Creek was severely dewatered in the reach adjacent to this diversion at the time of our survey. Fish passage issues at this diversion are clearly secondary to the dewatering problem. Water use at this diversion and all of lower Lost Creek should be investigated to seek opportunities to improve in-stream flow conditions. If the dewatering can be addressed, this site appears to be a good candidate for a screening project.

Dewatering at Beckstead Ditch headgate, August, 2011

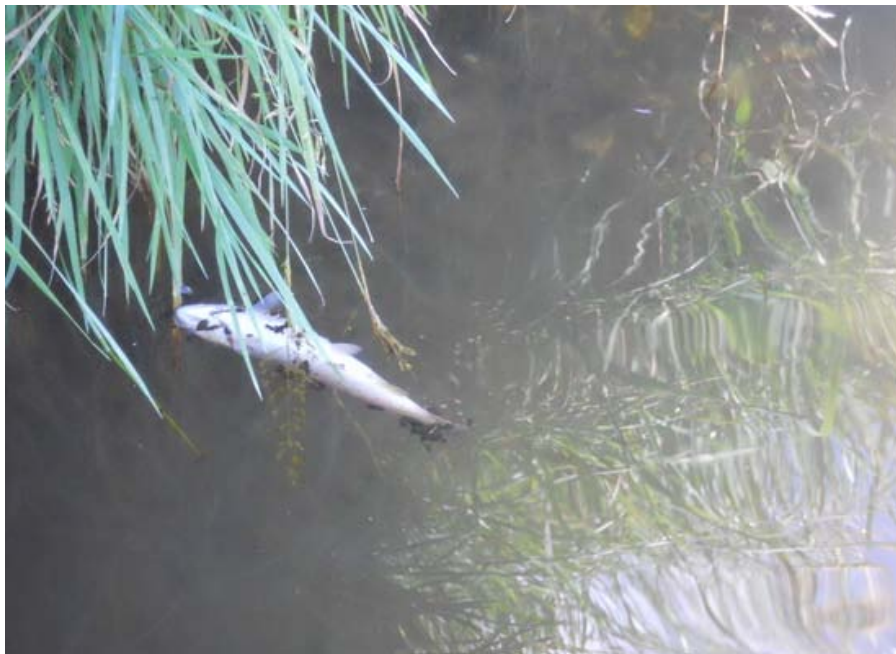
General Comments— The Lampert-Hadley Diversion consists of a screw-type sliding headgate and culvert set into the left bank at the outside of a bend in Lost Creek. At the time of the survey this diversion was taking the majority of the water left in Lost Creek. Large numbers of fish were staged in the pool adjacent to the headgate. Stagnant and warm water conditions appear to have contributed to a fish kill downstream with many dead trout observed in the creek channel.

Dead brown trout at Beckstead Ditch on Lost Creek, August, 2011 (warm water)
